**Submission to the  
NATIONAL TRANSPORTATION SAFETY BOARD**

**Investigation of Scaled Composites, LLC's SpaceShipTwo, N339SS  
Rocket-Powered Flight Test  
Koehn Dry Lake, California, October 31, 2014**

**May 29, 2015**

**Virgin Galactic, LLC**

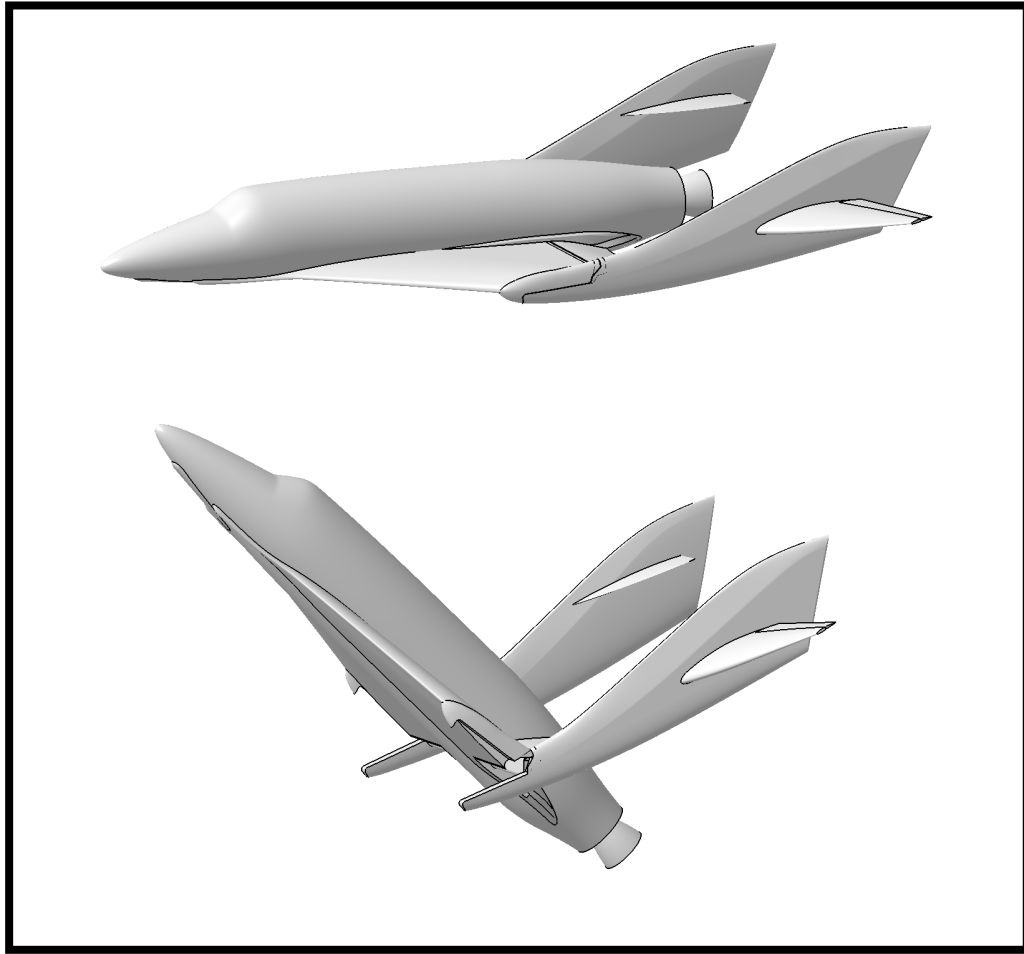
**Figure 5: SpaceShipTwo Unfeathered and Feather Up Configuration.**

The feather locks must first be unlocked by the copilot before the feather actuation handles can easily be pulled, deploying the feathers. To unlock the feather locks, the pilot moves the lock handles located on the center console downward to their mechanical stop. To lock the feathers, the pilot returns the handles to the up stop. The feather lock handles did not incorporate an automatic mechanical inhibit and it was therefore possible for the aircrew to lock or unlock the system during any phase of flight.

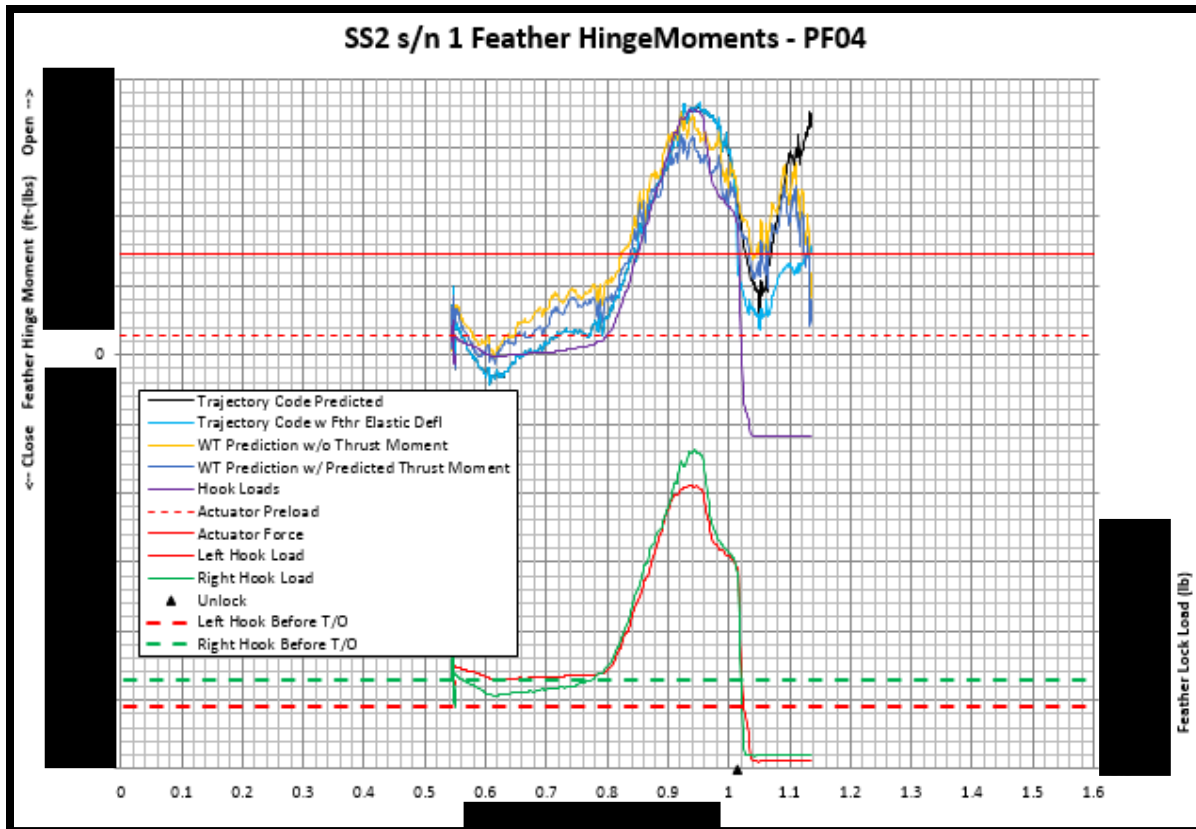
**Figure 9 – Feather Forces versus Mach Number**

Telemetric data reviewed by investigators demonstrates that, once unlocked, upward aerodynamic forces on the tail of the aircraft overcame the actuator pre-load and caused the tails of SpaceShipTwo to extend into the feather position.

These telemetric data are consistent with high upward load forces on the tail. Scaled Composites' former Chief Aerodynamicist stated that this was the flight regime where aerodynamic upload forces would cause the tails to feather, if unlocked. Referring to Figure 9, above approximately 0.80 Mach (if the feather locks are not engaged) aerodynamic forces overcome the actuator pre-load and the feather loses approximately 90% of its structural stiffness in countering an upward load on the tail. Above approximately 0.84 Mach with the feather locks unlocked, aerodynamic forces are of sufficient magnitude to extend the feather without any other action.

17. Once the feather locks were unlocked at 0.92 Mach, lift from the horizontal tails exceeded the feather actuator’s ability to prevent aerodynamic extension of the feather system. These forces caused the feather to extend without any further pilot action.
